# Aggressive Inspections

## SUMMARY REPORT

**Client:** Mr & Mrs Home Buyer  
**Inspection Address:** Your New Street, Your New City, New Jersey  
**Inspection Date:** 4/28/2013 Start: 9:00 am End: 12:30 pm  
**Inspected by:** Joe Milovitz

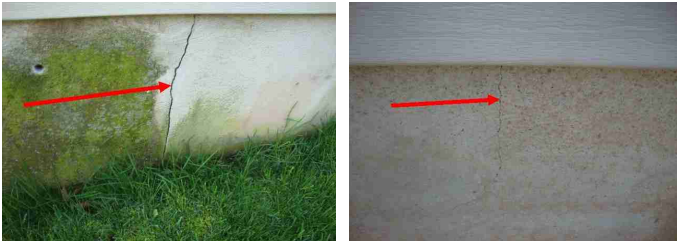
### Foundation Exterior View

There are a few cracks in the foundation walls. This is most likely due to settlement but these cracks can allow moisture damage to occur. It is recommended these cracks be sealed as standard home maintenance. It is also recommended that a qualified mason further evaluate and make any necessary fixes. If you deem further evaluation is necessary a qualified structural engineer should be contacted.
